THE SOUTH HOUSTON INDUSTRIAL AREA  
AN OLD LOFT SECTION IN LOWER MANHATTAN

# SOUTH HOUSTON INDUSTRIAL AREA

*Economic significance  
and condition  
of structures  
in a loft section  
of Manhattan*

by **Chester Rapkin**

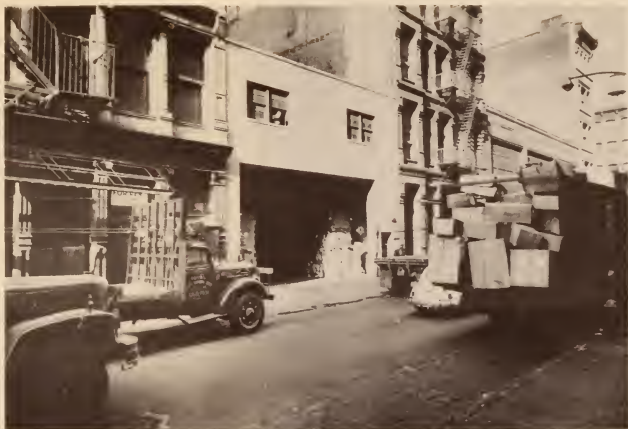
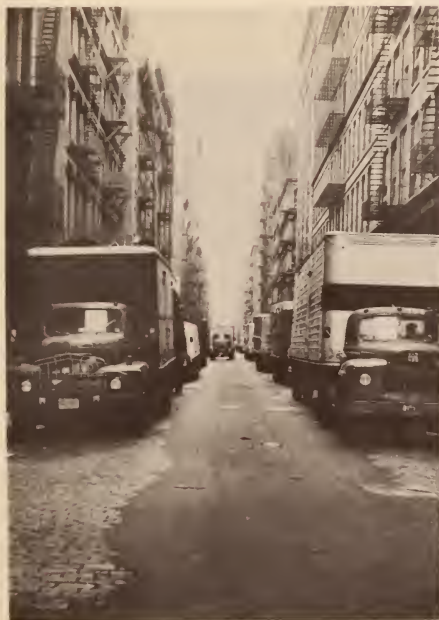
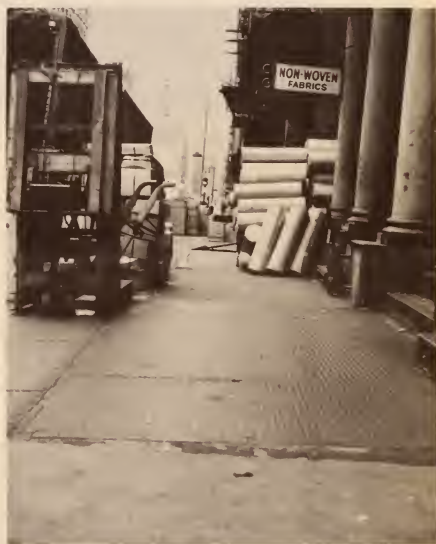
There is much movement of goods in and out of the area. Sometimes it is goods in process or finished product, other times waste material. In all instances, it goes by truck and, strangely enough, trucks usually find a berth at a nearby curb.

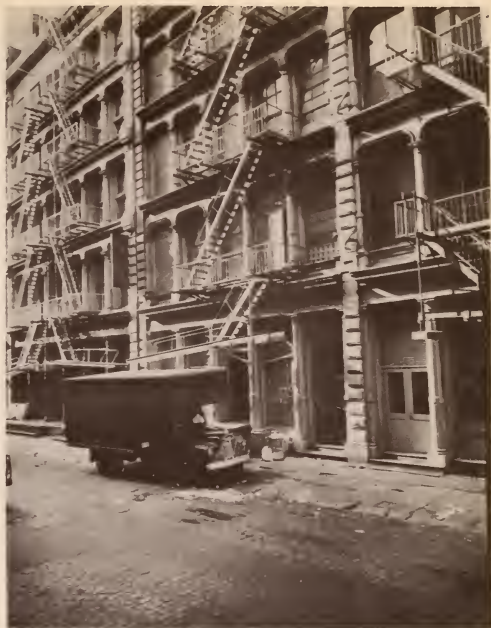
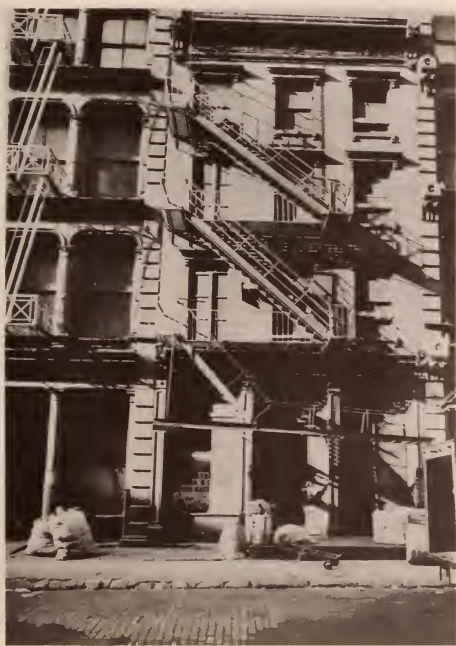
The facade of these buildings betray their age, for the cast iron pillars mark the period between 1875 and 1895. Although the typical building is five to six stories high, there are a few smaller structures usually inherited from an earlier era. In most cases, the full lot is covered, and often basement space is extended by excavations under the sidewalk.

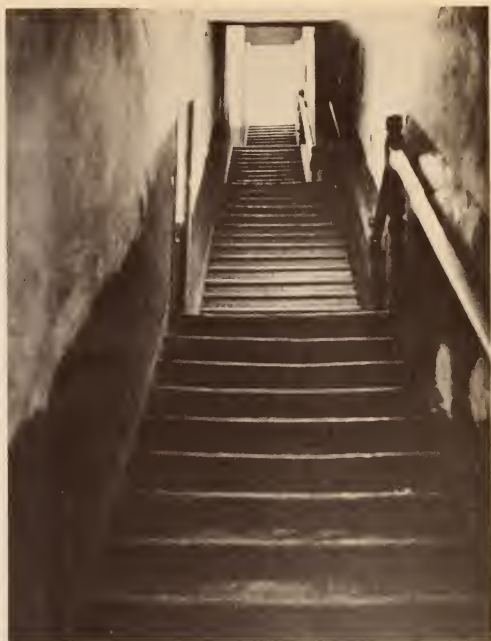
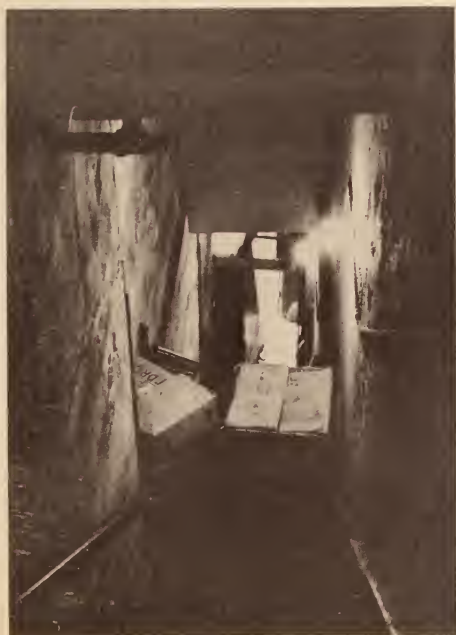
The linear staircase extending uninterruptedly from the ground floor front to the top floor rear is commonly encountered. Sometimes it is clear of obstructions; at other times, it is not.

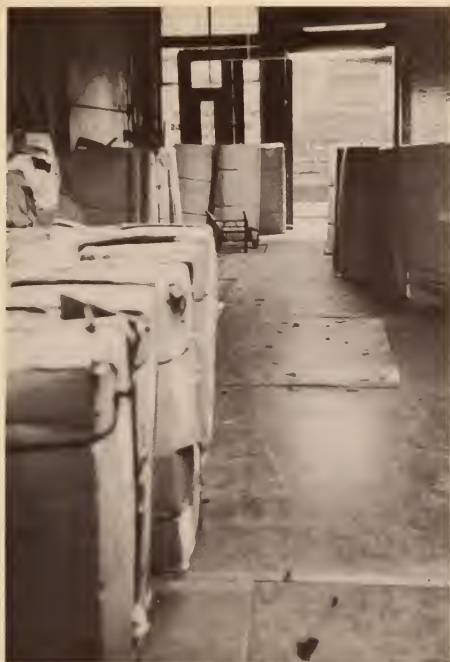
Many of the buildings are used for wholesaling and storage. In some cases, goods are baled and stacked neatly with aisles clear of obstructions. In others, burlap sacks or loose goods are strewn about the premises.

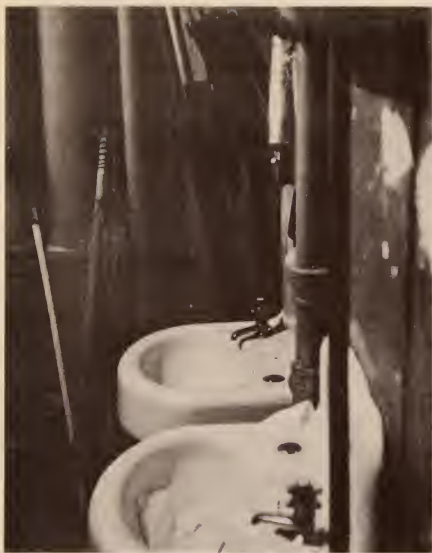
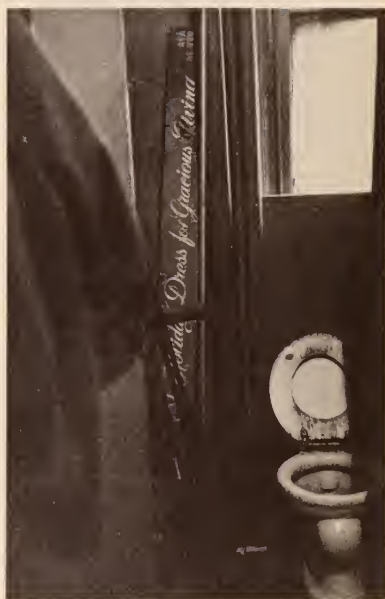
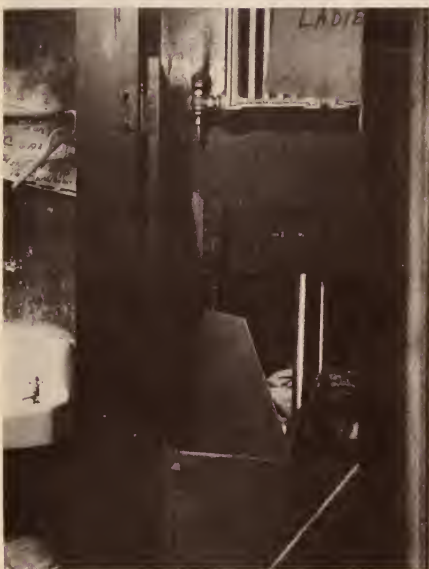
Ladies retiring room. Worse than the average, but not as bad as some others.

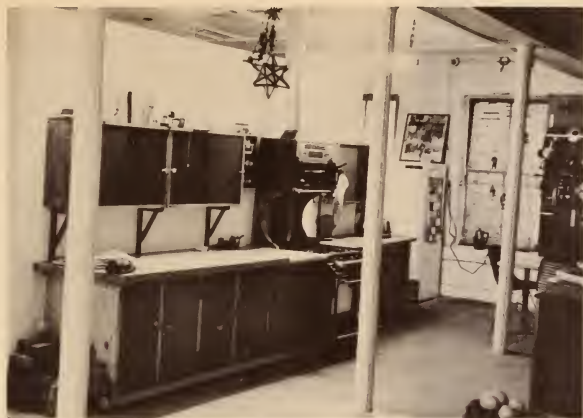
AIR 4- Artist in residence on the fourth floor. Behind this inauspicious exterior a man of creativity and taste has transformed bleak, undifferentiated space into a graceful atmosphere for working and living. While infrequent in the twelve-block area, artists of many types have taken to lofts in nearby sections of Manhattan.

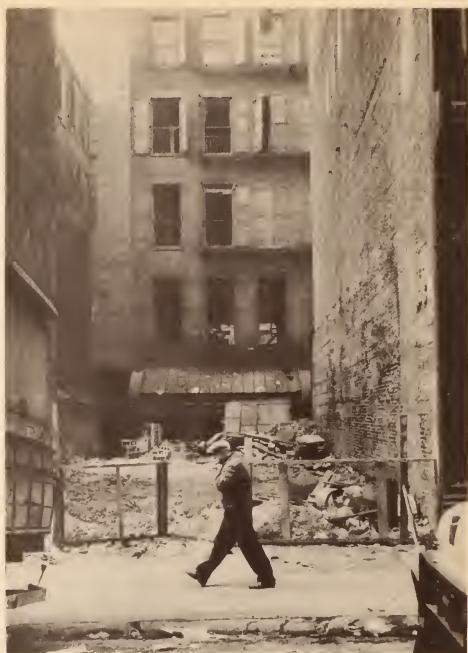
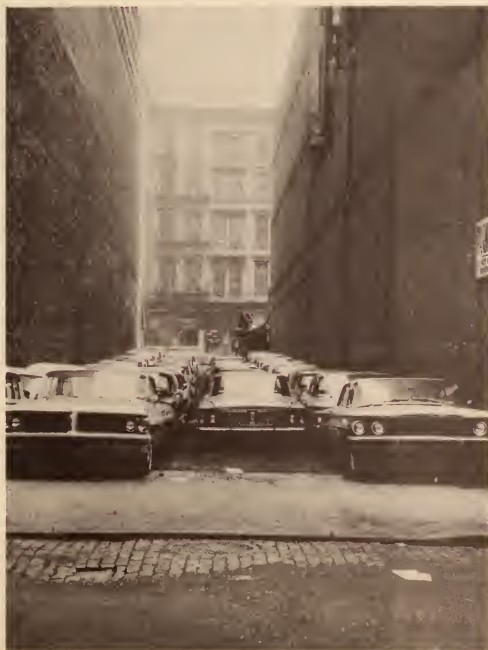
Of the eleven vacant lots, a few are used intensively for automobile parking. Others merely serve as repositories for refuse. The space they provide is insufficient in size or too limited in shape to be used for more productive purposes.
